The
San Francisco Earthquake and Fire

A BRIEF HISTORY OF THE DISASTER

A. L. A. HIMMELWRIGHT, C.E.

THE ROEBLING CONSTRUCTION COMPANY
FULLER BUILDING, NEW YORK, N. Y.

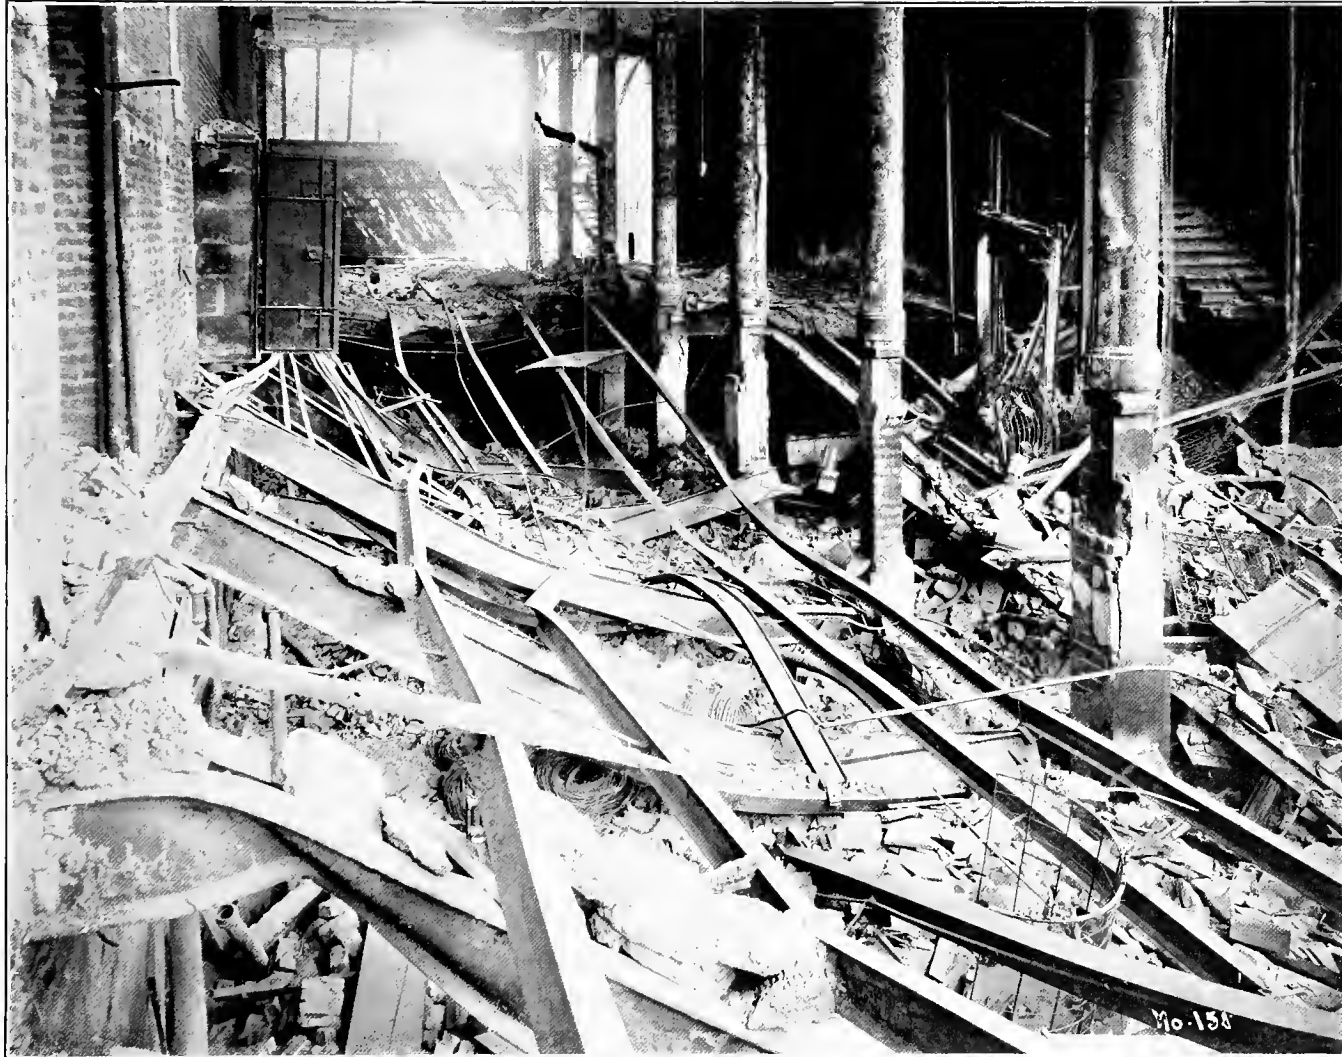
HOBART BUILDING. First floor. View from the sidewalk at the front of the building. A hot fire in the basement caused the excessive deflection of the unprotected girders, which pulled away from the flimsy column connections, permitting the greater portion of the first floor to fall into the basement. The column protection is of metal lath and plaster in the first story, and of hollow tile 2" in thickness in the upper stories.

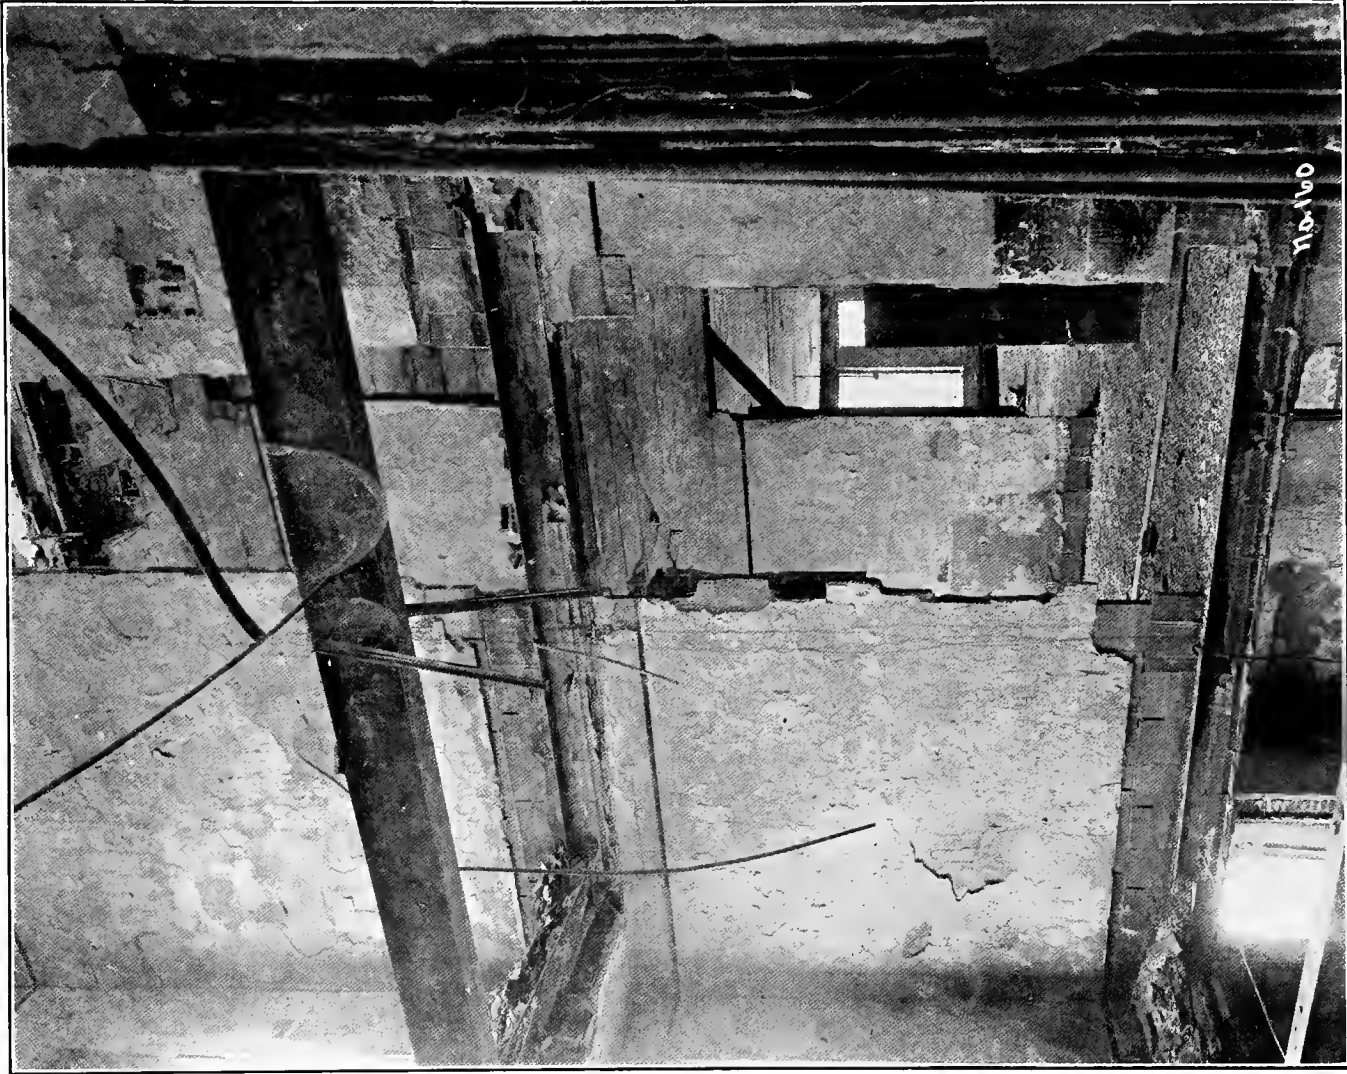
The steel frame work in the lower stories is in good condition. The roof was supported by three large trusses within hollow tile partitions. The latter failed in the fire, exposing the trusses to the heat, causing them to buckle and deflect. The middle truss failed, partially fracturing the top of the wall columns supporting it and falling to the seventh floor. The impact of the steel frame work and roof tiles striking the seventh floor, knocked out four spans of the hollow tile floor arches, which in falling broke down many of the arches of the floors below them. The wreck of this truss bulged the east and west walls badly, so that they are temporarily tied together by cables. The parapet wall on the east side is down.

The floor arches are in fair condition. There are many places where the soffits of the tile blocks have fallen away, exposing the cellular spaces. The partitions are badly damaged throughout, a large proportion of the blocks having fallen down. Safes also caused the failure of some of the floor arches in this building.

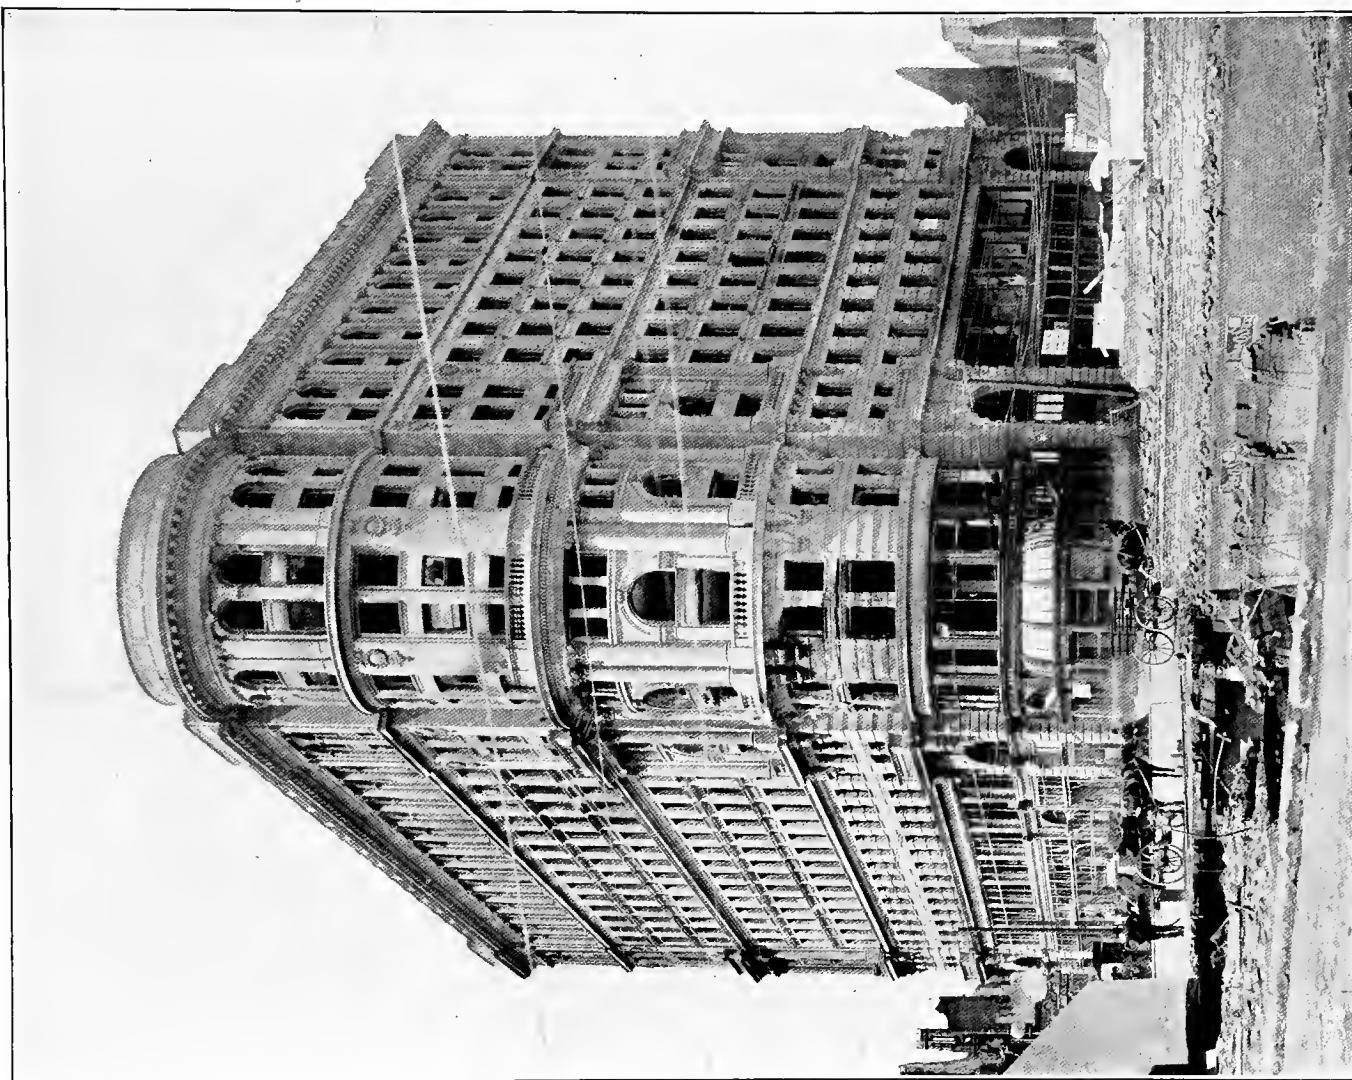
JAMES FLOOD BUILDING. Powell and Market Streets. The façades are of Colusa sandstone, with a pink granite base to the water table. The damage to the exterior consists of spalling around a number of the window openings and earthquake cracks where the corner tower joins the side walls, and at the northwest corner pier of the Powell Street side at the first-story level. The fire-proof floors are of hollow tile arches, segmental in form, with Roebling flat wire lath and plastered ceilings underneath. The column protection, partitions and wall furring consist of hollow tile blocks. The floors are in good condition, except a section over the central portion in the first story. A fire of greater intensity occurred in this location, causing the failure of the wire lath ceiling. When the latter fell away, the hollow tile blocks above it were damaged by the fire, exposing the cellular spaces over a considerable area. The hollow tile partitions stood as well in this building as in any in the burned district, but about 15 per cent. of the partition areas are down. The hollow tile column protection was badly damaged in many places, but fulfilled its purpose and prevented the failure of the columns.

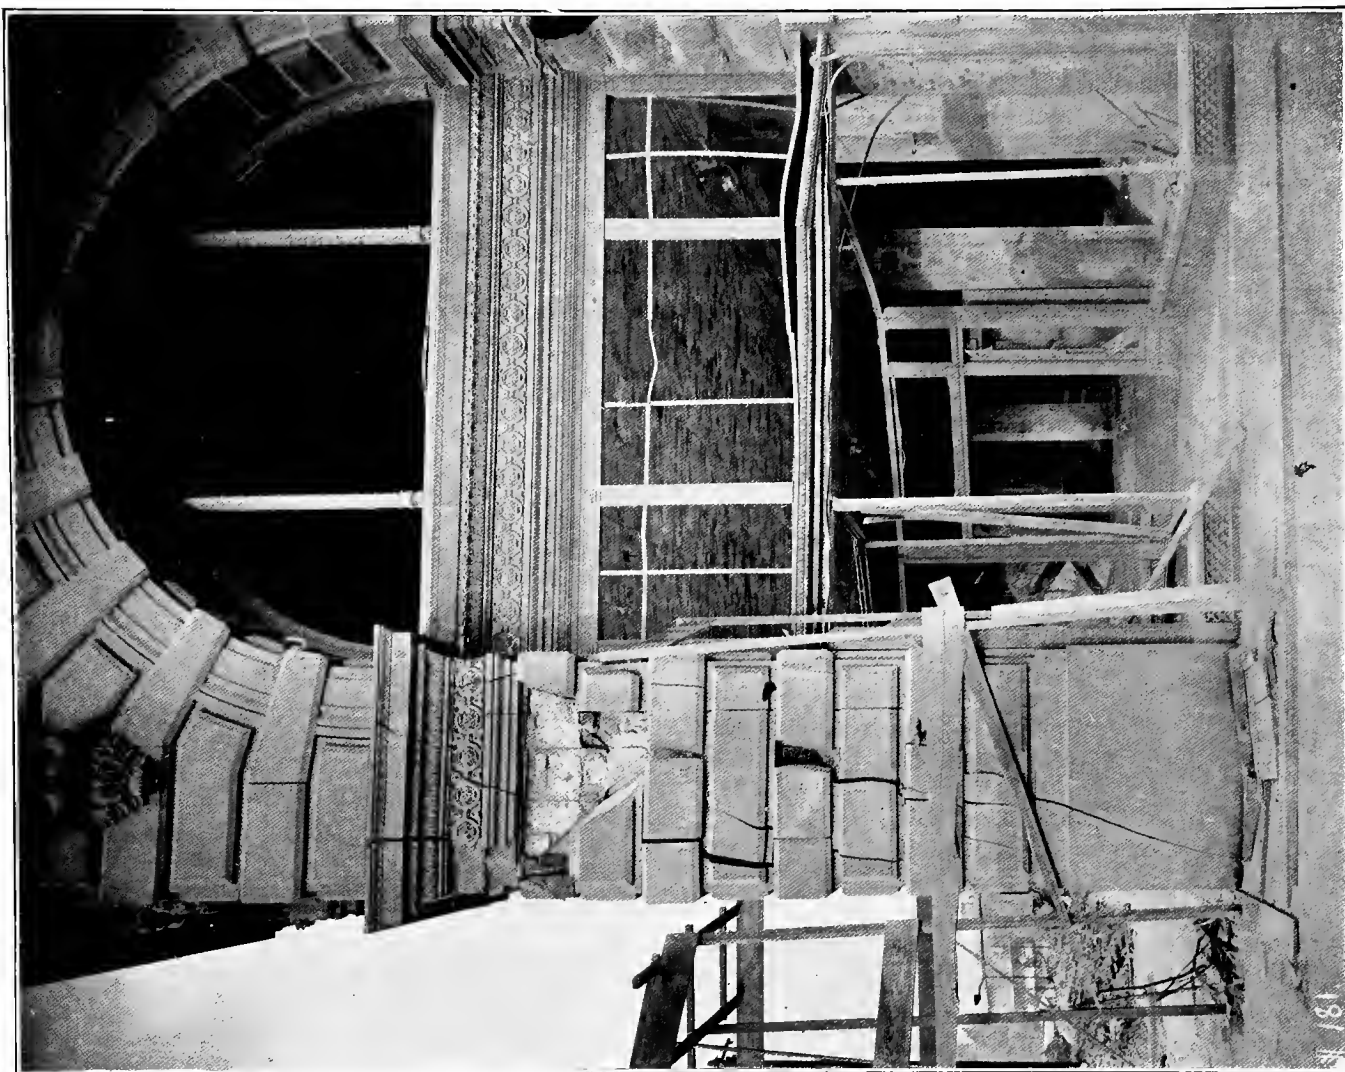
window openings are also considerably spalled in places on the Powell Street side, those on the west side at the fifth and sixth stories being injured most. Where the semi-circular tower joins the Market and Powell Street walls, both sides are considerably cracked by the earthquake. The northwest corner pier of the Powell Street side is also racked and shattered by the earthquake. The east half of the Ellis Street front is very badly scaled and spalled. The northeast corner is greatly damaged by the earthquake. The east gable wall of brick is in good condition.

The levels on the water table indicate that the foundations remain level and intact. Observations on the different corners of the building show that the walls remain perfectly plumb. The steel skeleton frame is uninjured.

The hollow tile floors are in good condition throughout, except in the first story and several other smaller spots where the wire lath and plaster ceiling fell away. Where this occurred, the tile blocks are badly damaged, the soffits having failed and fallen away, exposing the cellular spaces. The concrete arches in the roof remain uninjured, and the suspended ceiling underneath is in good condition, a large portion of the plaster still adhering to it.

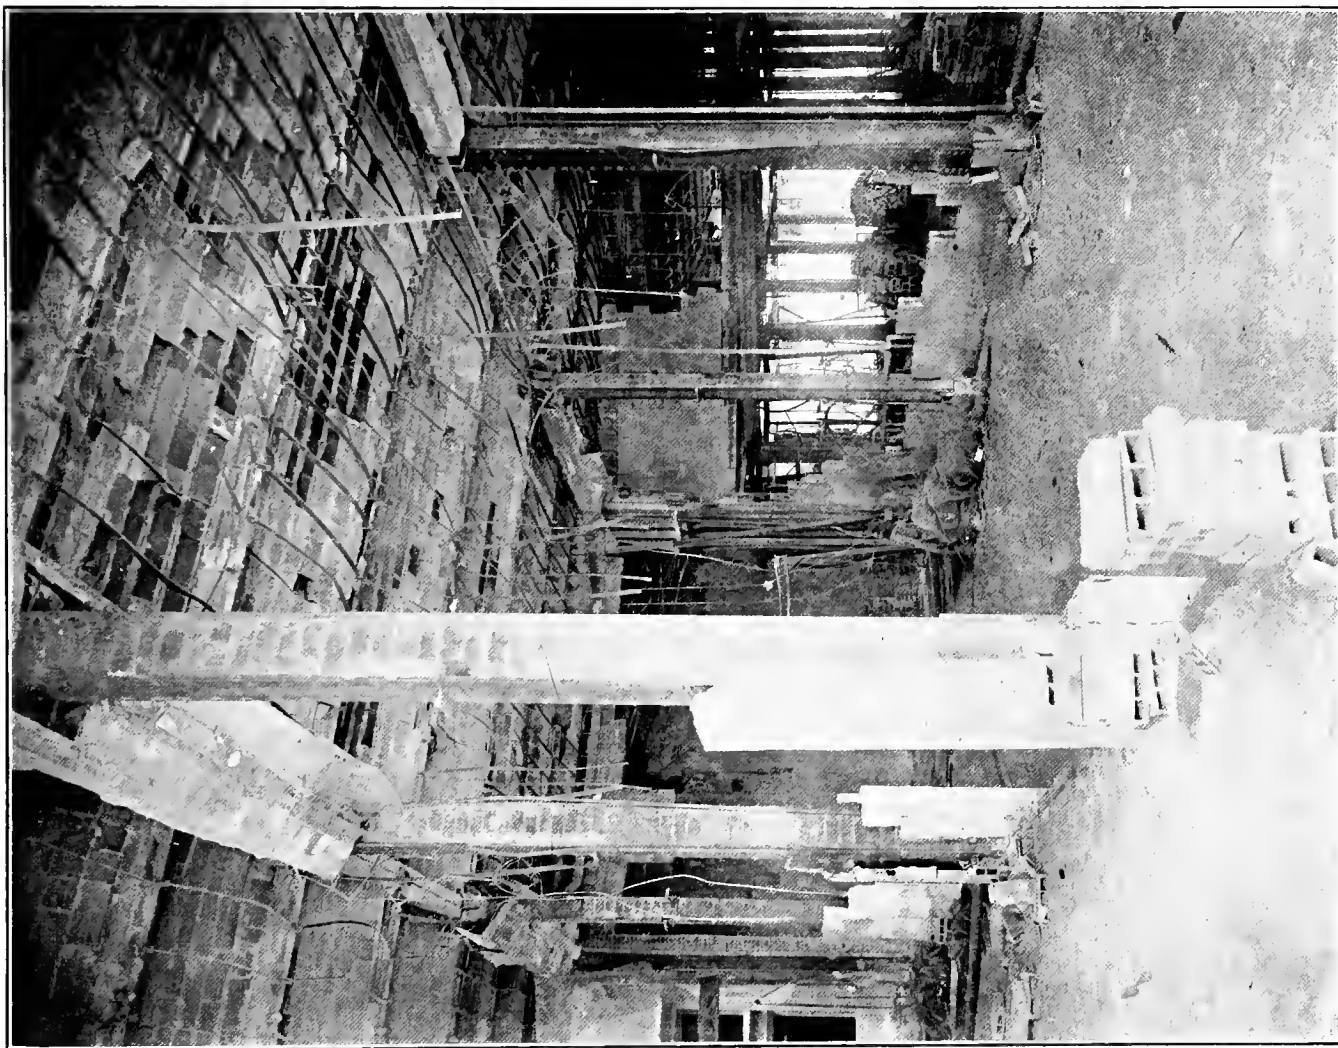
JAMES FLOOD BUILDING. Showing the earthquake damage to the northwest corner pier at the first story level.

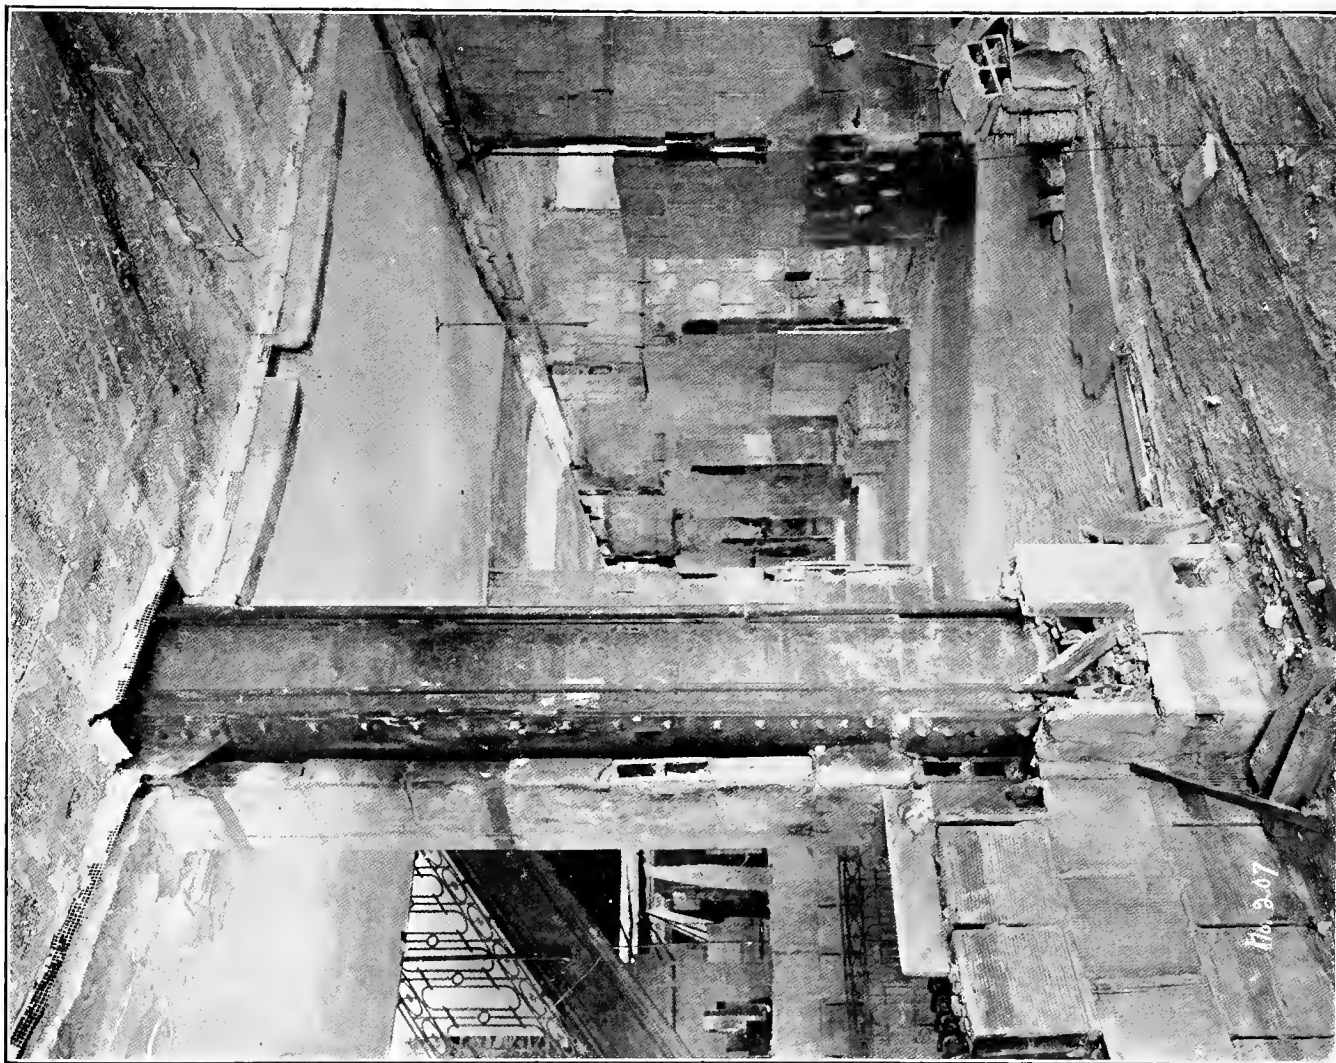
FLOOD BUILDING. Fourth Story, southwest corner. Showing typical damage to the 4" hollow tile partitions that were built solidly from the top of the fire-proof flooring through the Roebbling wire lath ceiling to the under side of the hollow tile arches above. Under these conditions, when the partitions expand from heating, there is a tendency to buckle or deflect, which frequently causes failure. The blocks over the door openings have generally been forced down into the opening, and have dropped out from this cause. Some of the partitions that remain standing are weak and in a tottering condition. This illustration shows also the brick-filled column inclosed by 3" hollow tile blocks. This is an improvement over the ordinary method, but could be rendered still more efficient by filling the space between the hollow tile protection and the steel member solidly with cement mortar, and by providing a separate enclosure for pipes.

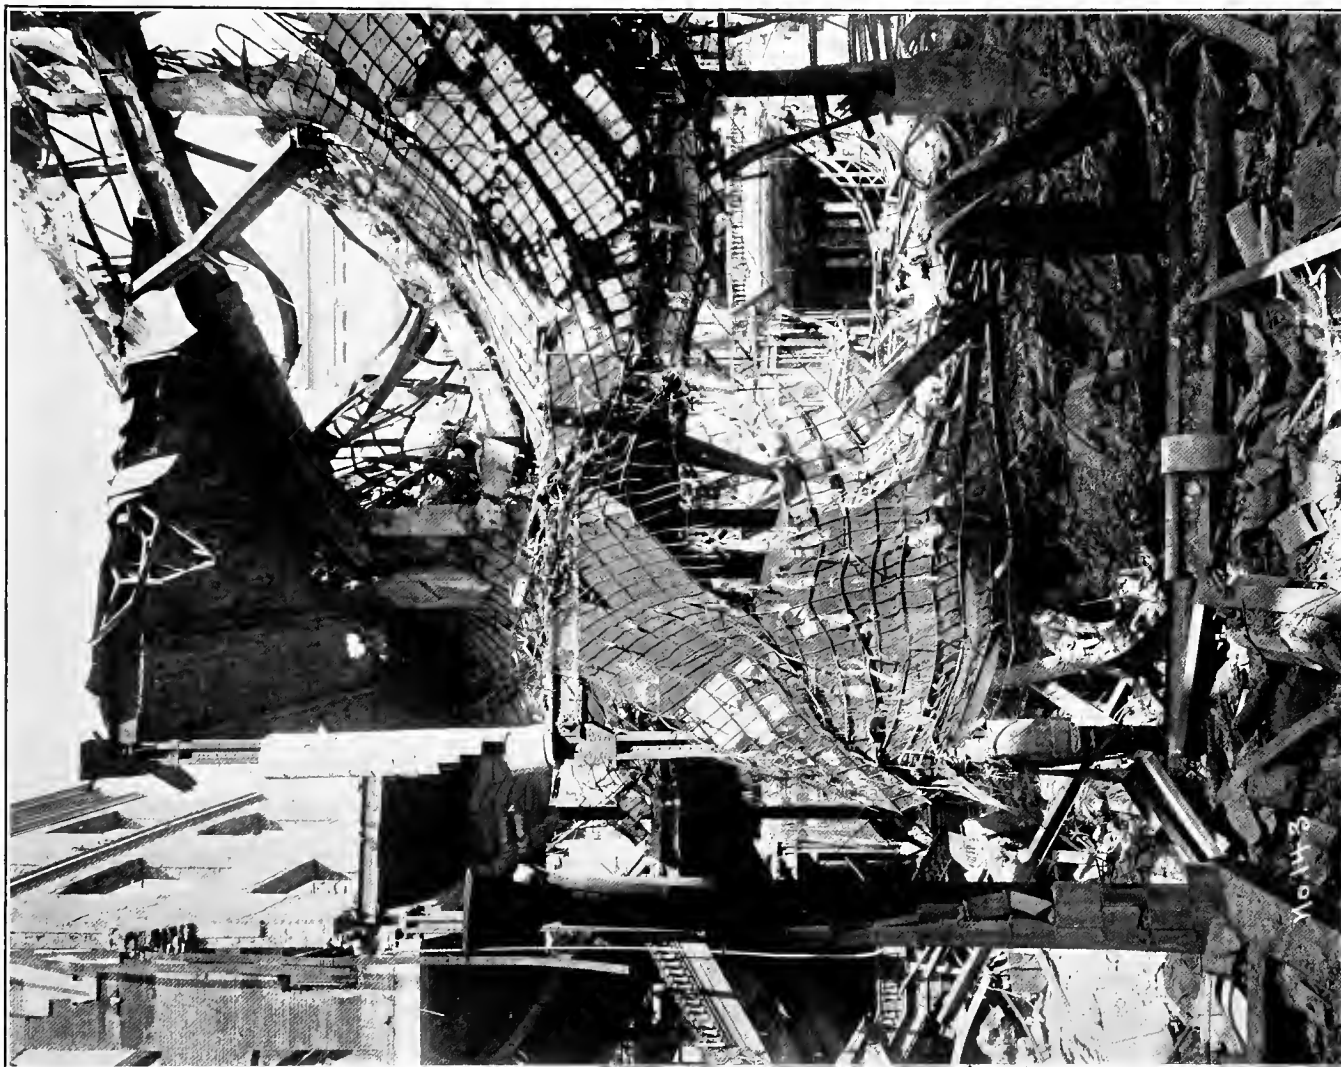
There are a large number of columns that have buckled from the heat in the basement story adjacent to the collapsed sections. There are also numerous buckled and deflected columns in different portions of the building that show evidences of having been heated to a red heat after the hollow tile column protection had failed. In some cases these columns have doubled over on themselves and present very curious, though interesting, studies of the manner in which steel fails when highly heated. It is noticeable that wherever the steel work is considerably warped, the hollow tile blocks have fallen out. The light steel, wire lath and plaster ceiling construction, with the plaster still adhering to it, is lying about over the floors in all manner of grotesque shapes and clinging in sheets to portions of the steel framing in places.

The cast-iron stairway, elevator shafts, mechanical and power plant and all the fixtures and appliances are totally wrecked.

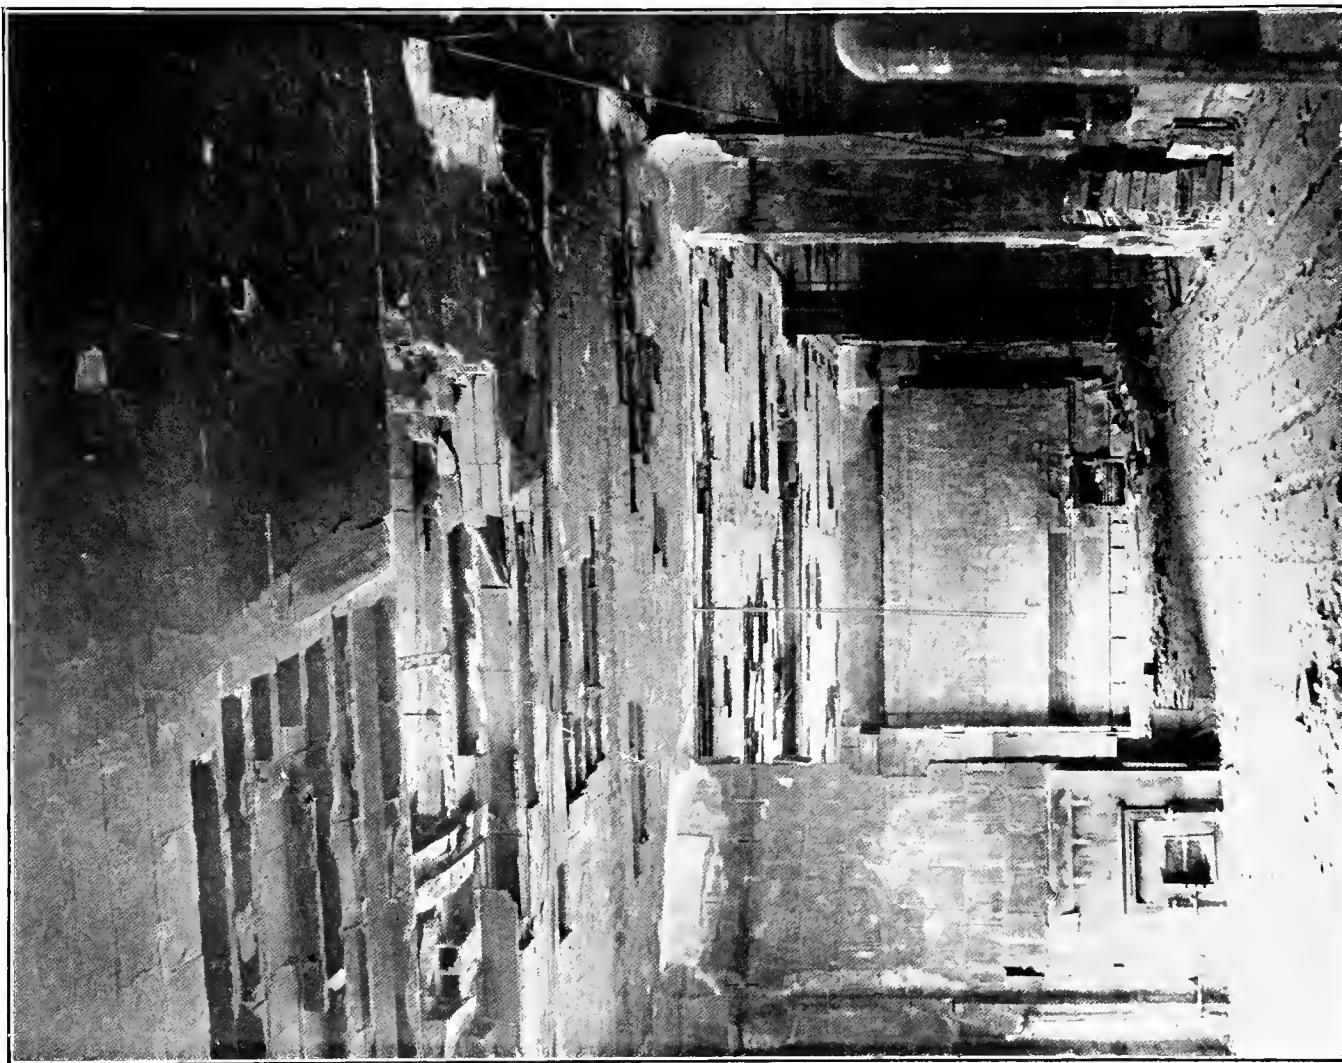
The levels on the water table indicate that the northwest corner is about 1" higher than the other three corners. The greatest observed variation of the walls from the plumb is at the southwest corner, where the west wall leans to the west about $\frac{7}{8}"$. The chimney at the northerly corner of the light well is about 2" out of plumb, leaning to the south.

In the ninth story, a column near the east end is badly deflected on account of the failure of the hollow tile protection. In the eleventh story, the $5\frac{1}{8}"$ diameter wrought-iron pipes, of $\frac{7}{32}"$ metal, supporting the light framing of the wood roof, failed in several places, causing the total wreck of the roof framing and much damage to the eleventh story floor. These light columns were simply wrapped with metal lath and plastered, the plaster being only about $\frac{5}{8}"$ in thickness and in contact with the pipe.

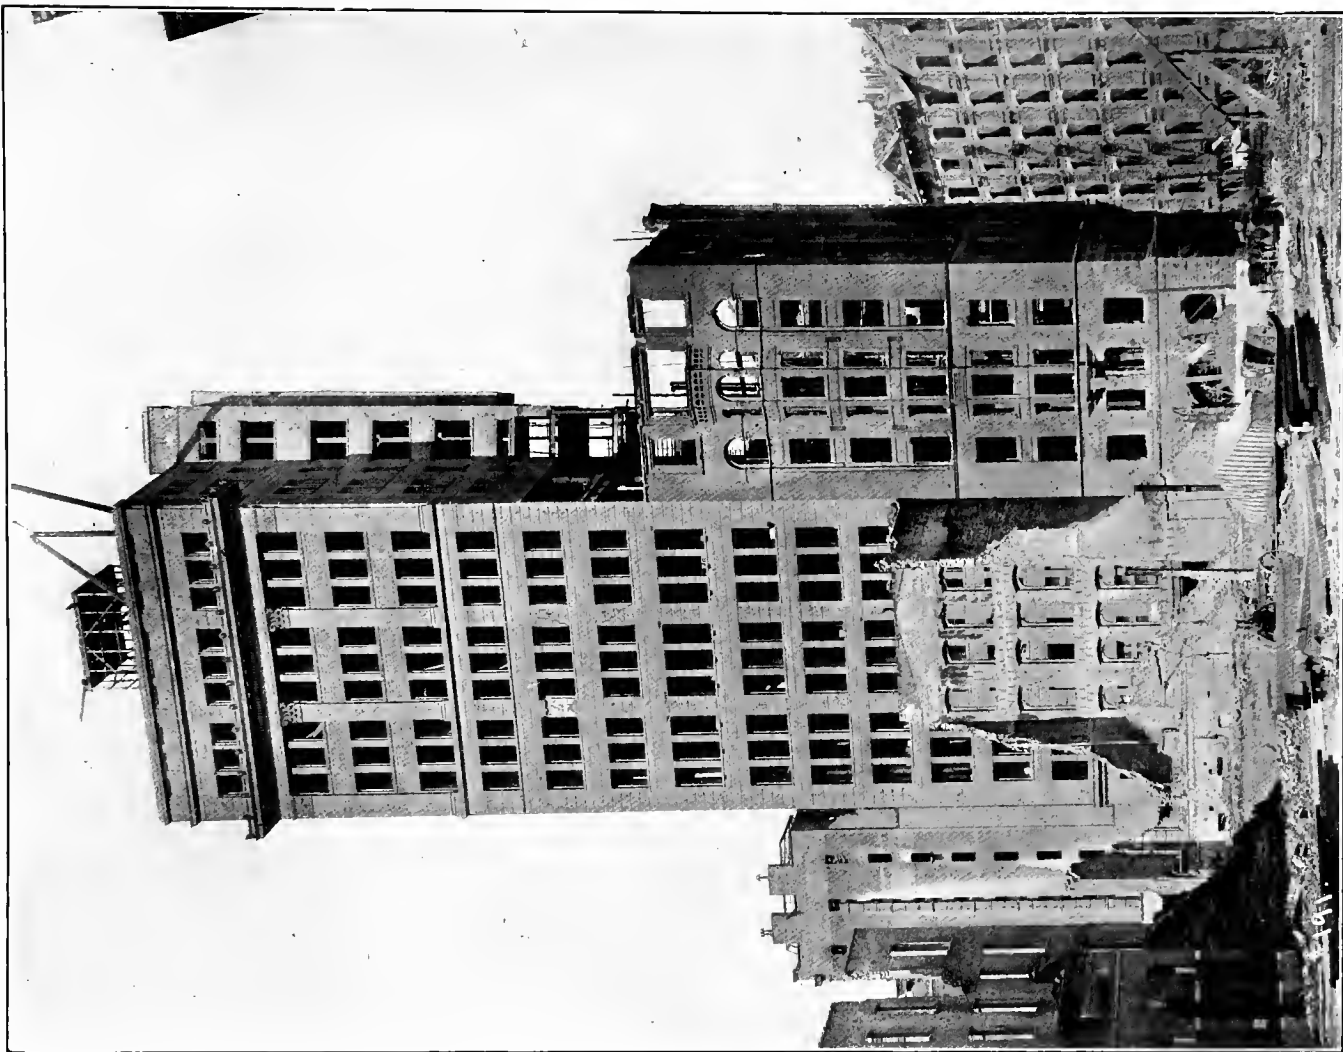
This building was subjected to a normal fire only. The sand-stone of the Kearny Street front at the first story is very badly spalled. The red brick of the second story, and in the upper portions of the building, is practically uninjured, but some of the terra cotta ornamentation is damaged. The Market Street front is apparently in good condition, it being very little spalled and having no earthquake cracks.

The levels at the water table show that the foundations remain practically level. Observations on the southerly front show that it leans about 4" to the south at the southwest corner. The Market Street front leans to the south about 3¼" at the southeast corner.

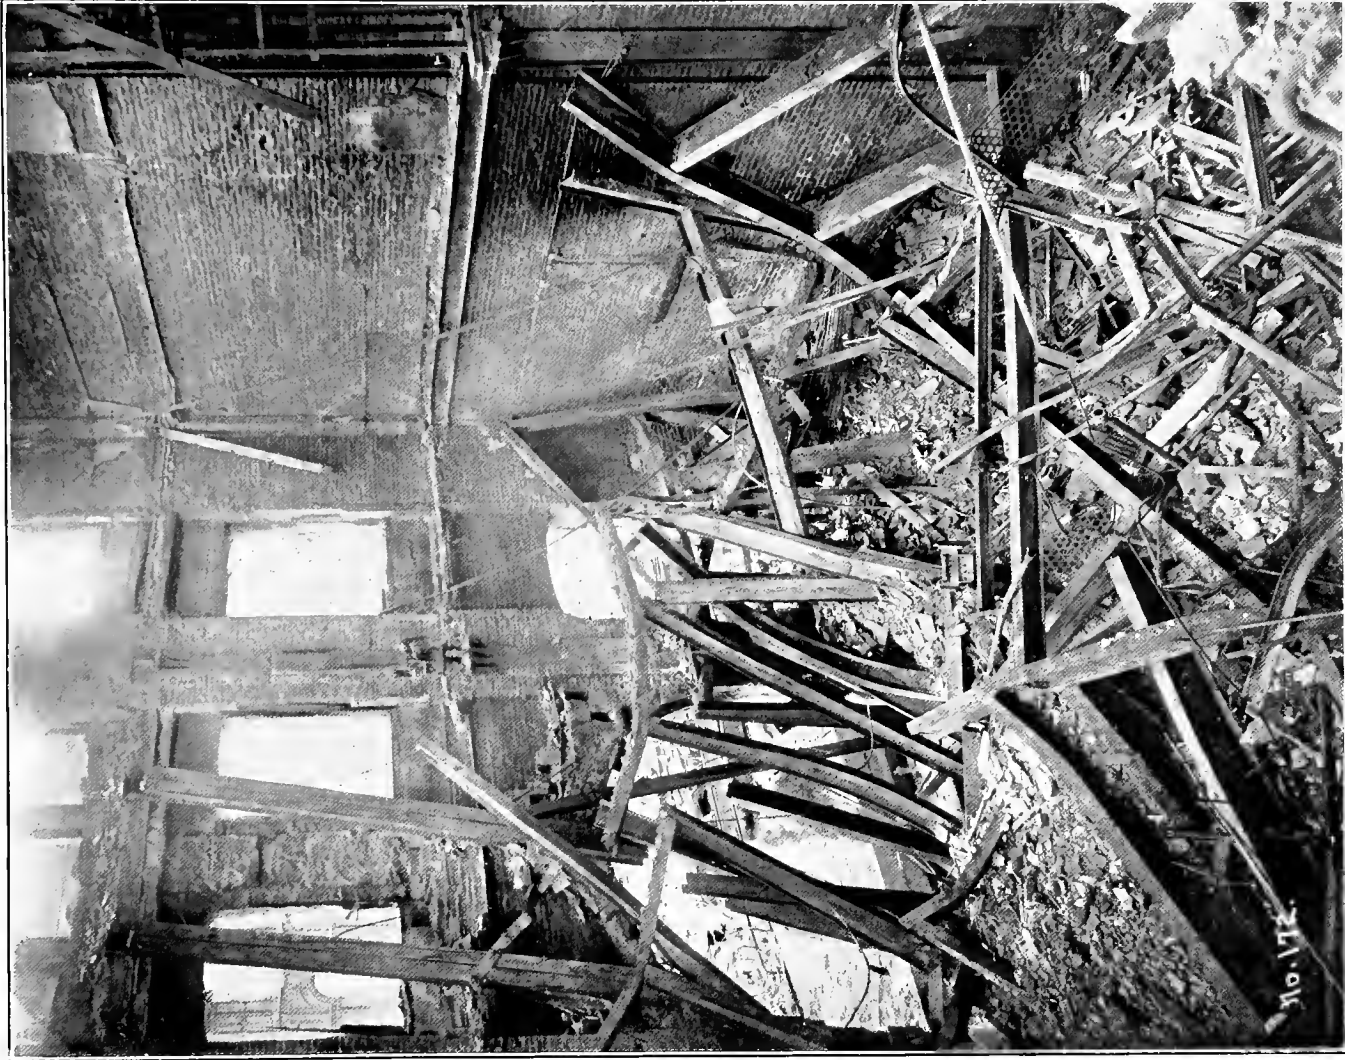
CHRONICLE BUILDING AND ANNEX. Junction Kearny and Market Streets. The original building is on the right. The brown stone of the first story is badly damaged, but the pressed red brick above is uninjured. Some of the terra cotta ornamentation around the brickwork is spalled. The burning of the wood roof no doubt started the precipitation of 19 linotype machines in the top story on the Kearny Street side, which fell to the basement, carrying with them successive tiers of steel framing and hollow tile arches underneath. In the rest of the building, the hollow tile arches are damaged in many places; the 4" hollow tile partitions are badly wrecked; and the 3" hollow tile column protection is damaged, and has fallen away in spots.

CHRONICLE BUILDING. Showing the interior on the Kearny Street side, which collapsed from the roof, the wreckage filling the basement to the ground-floor level. The columns are of cast iron, with steel framing supporting the floors. Two double beams supporting bay window projections on the left-hand side have broken off at the separator holes and remain hanging in a vertical position. The fire-proof floors were built of the old-style single cell 9" hollow tile blocks. A wood roof and 19 linotype machines in the top story are responsible for this damage.

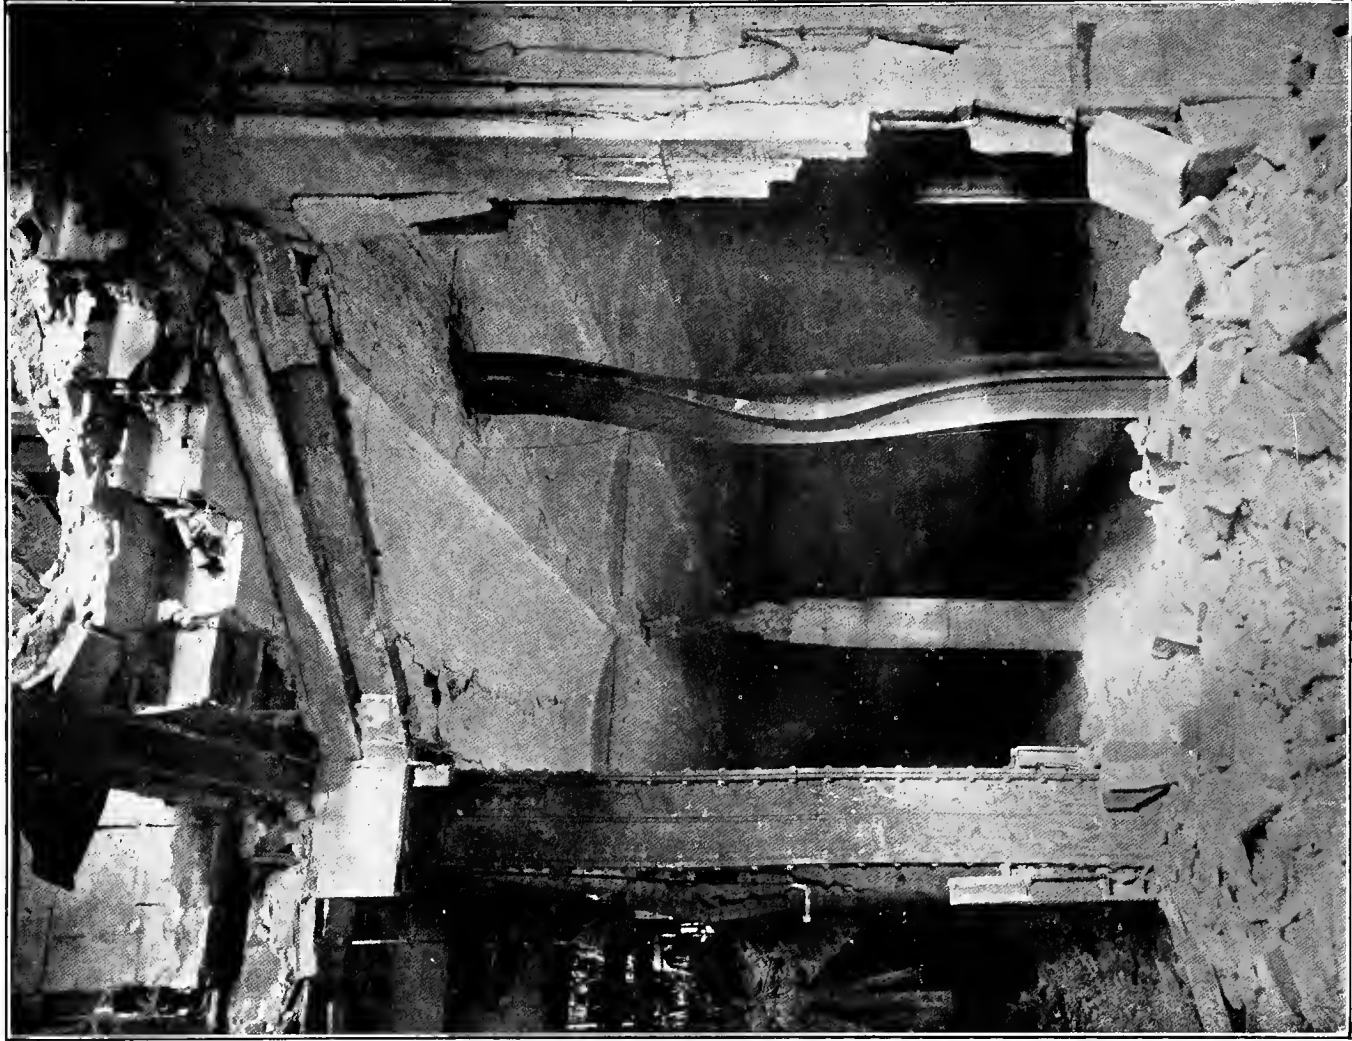
The levels on the water table indicate that the front half of the foundations of the building remain level. It was impossible to find corresponding points in the rear of the building to make comparisons. The south front of the building is considerably out of plumb. At the southwest corner it leans to the south about 4". The Montgomery Street front remains plumb.

On account of the failure of the hollow tile column protection, the steel frame of this building has suffered considerably. In the basement there are three main and one secondary columns that have buckled. The steel members supporting the mullions between windows facing the light court are badly buckled in many cases.

The hollow tile floors have been considerably damaged throughout. At numerous places there are large areas where the soffit members of the floor blocks have failed and fallen away, exposing the cellular spaces. Several safes have fallen from the upper stories and broken through successive floors to the basement.

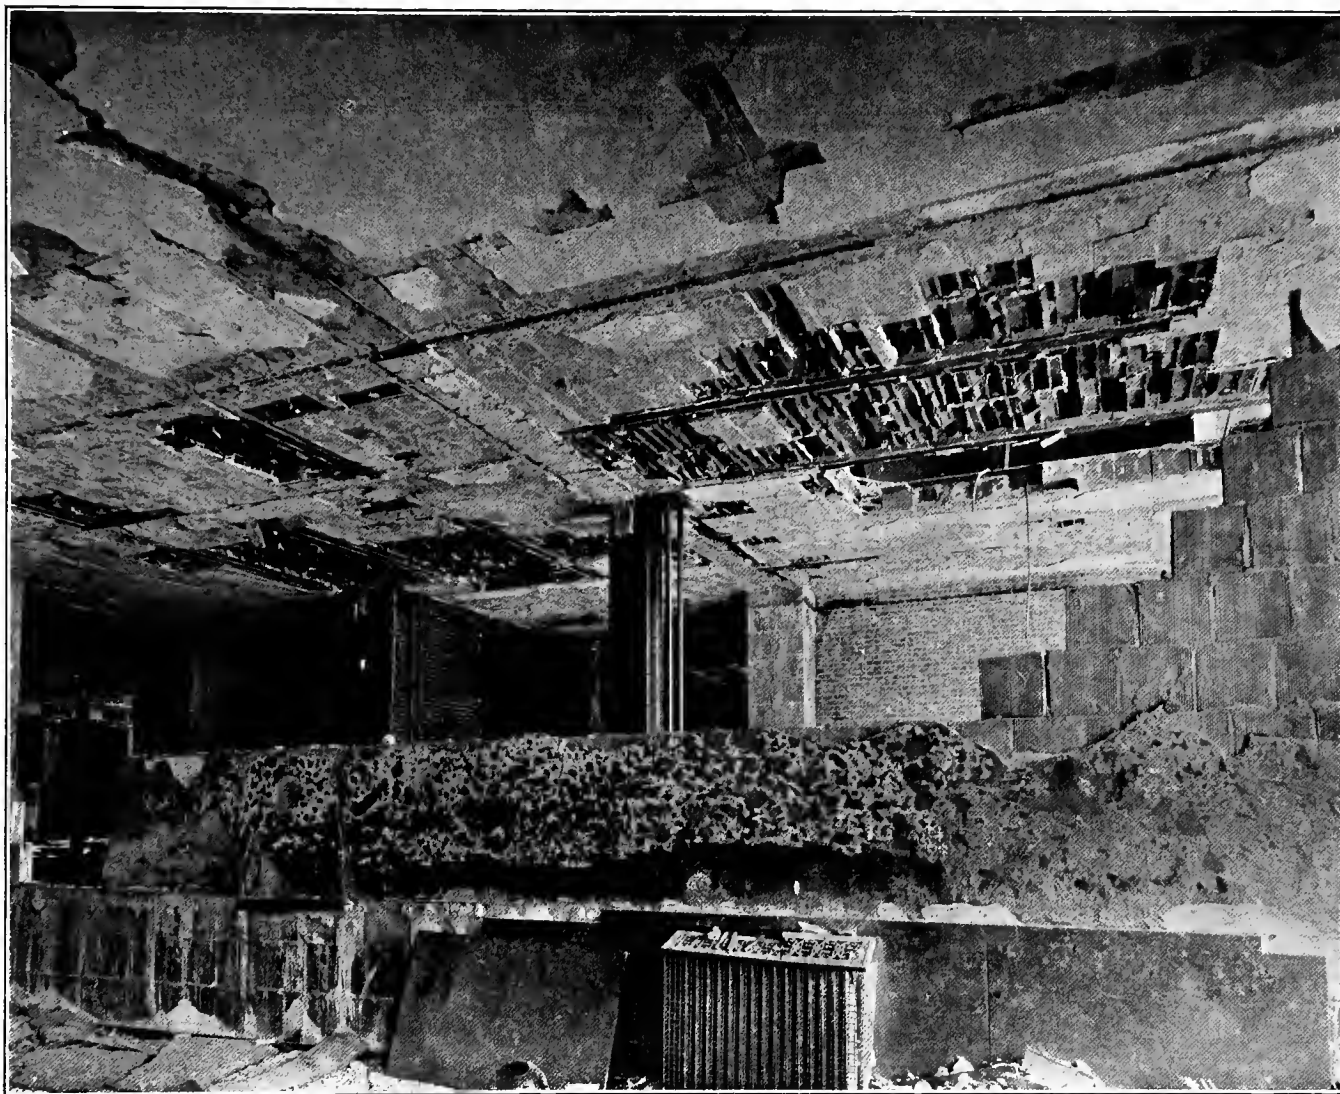
MILLS BUILDING. Basement Story. Showing the damage to the hollow tile protection of the columns. The deflected columns were caused by the total failure of the protection.

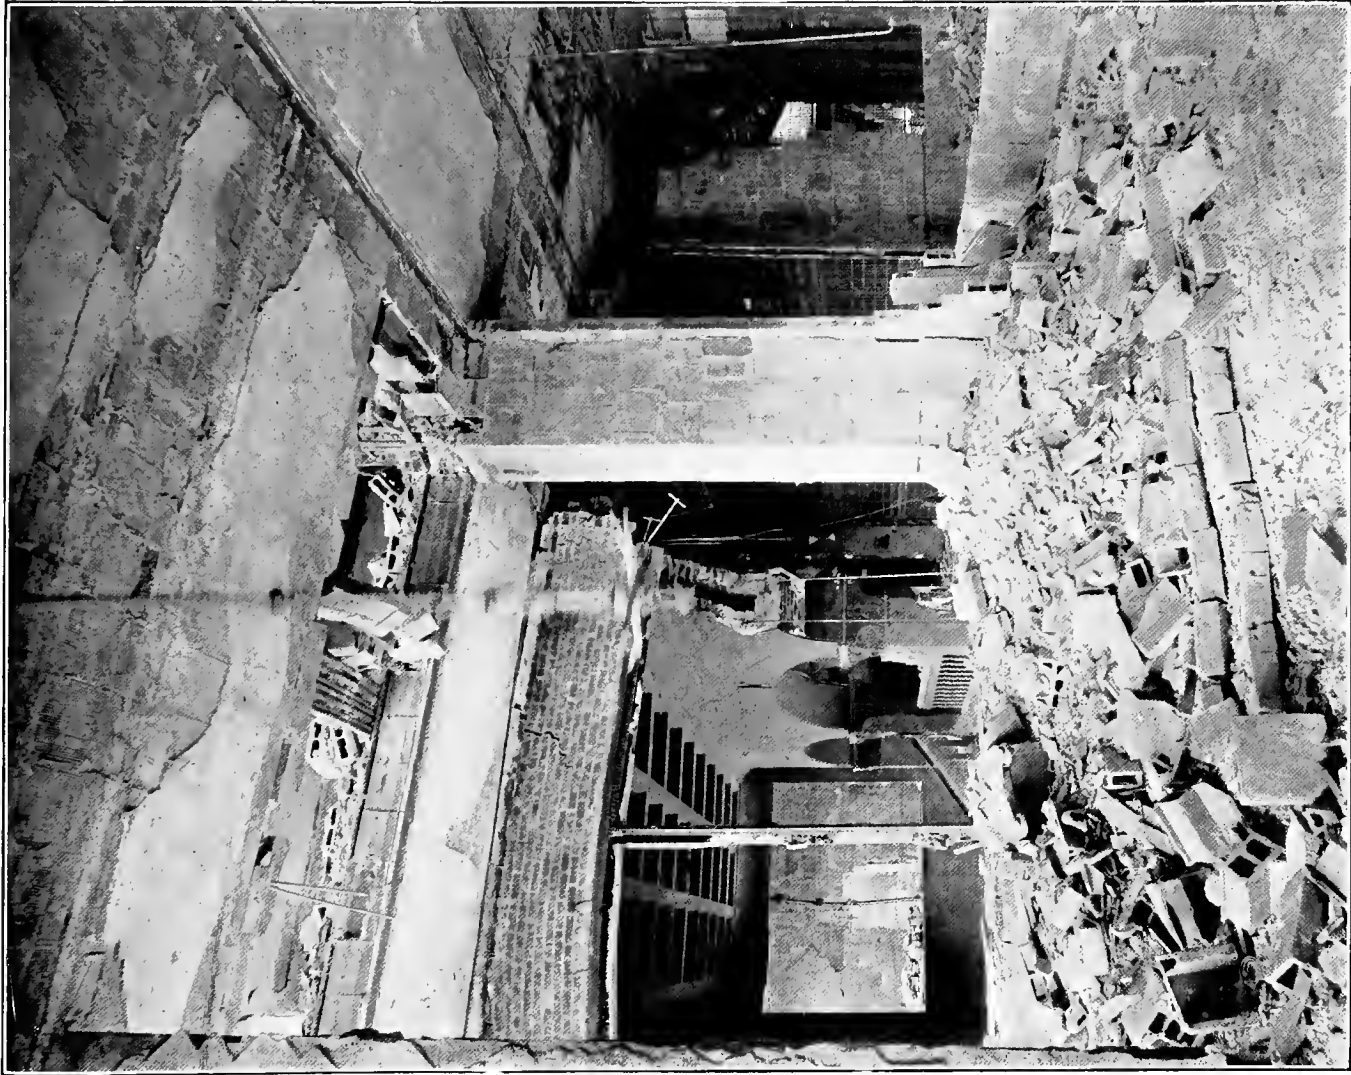
MILLS BUILDING. First Story. Showing the damage to the hollow tile floor arches, column covering, and partitions. The vault of the Scandinavian Bank, at the right, is uninjured. Note the separate shaft for pipes outside of the column protection, at the left.
